ENGINEERING DEPARTMENT
SUBJECT MILLINGTON N.J.
SOIL EROSION

ENGINEERING REPORT

78M-1

ENGINEERING REPORT 78M - 1

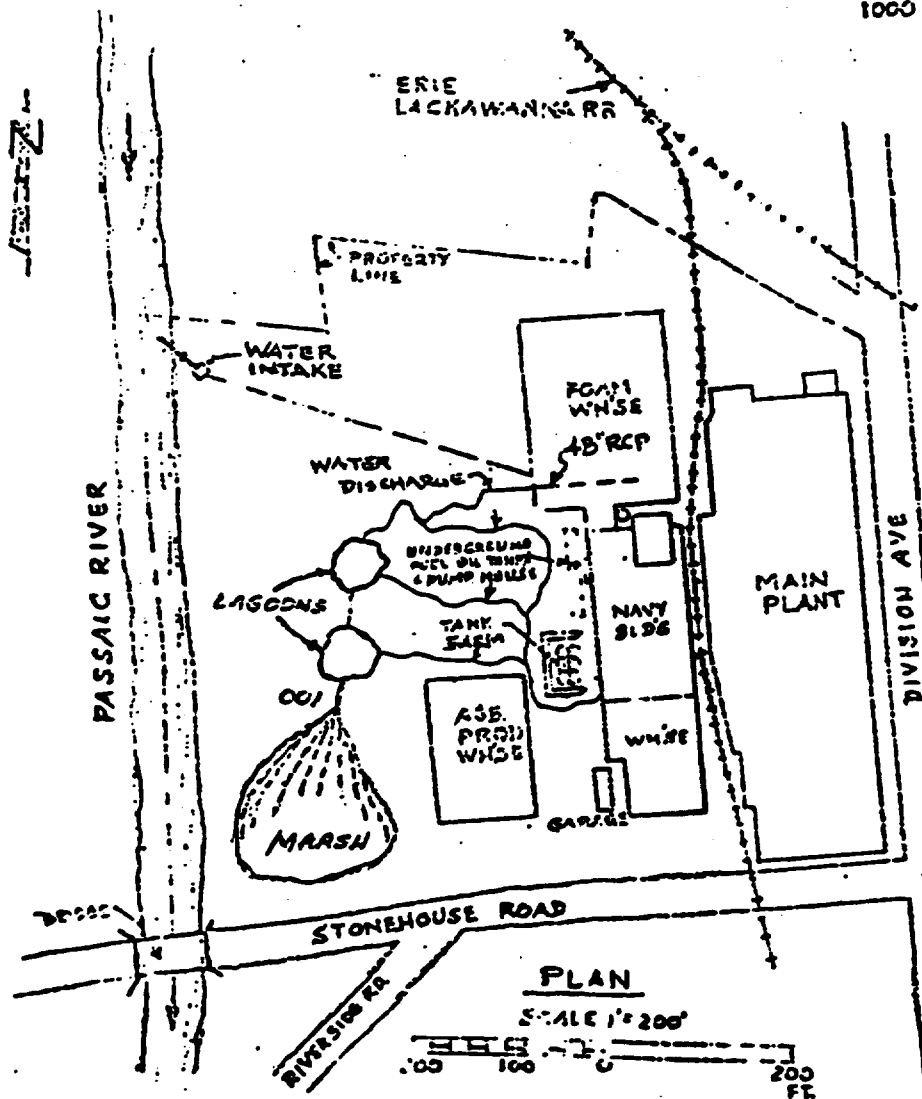
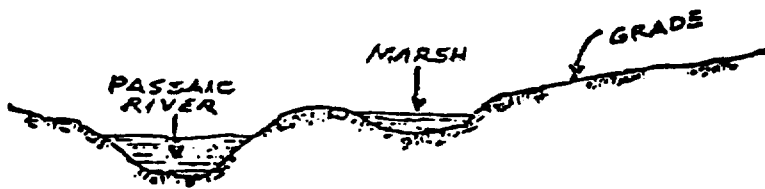
EXHIBIT 'A'
 ASB 002 0071

The problem results basically from site inactivity and the inability of storm water to follow the water course previously established for the industrial water discharge system. (See Exhibit A).

Lack of normal plant maintenance during the recent periods of inactivity also resulted in corrosive and storm weathering attack to rain gutters and down spouts on portions of the plant buildings. This storm water spills to the building foundation area where it joins with run-off from the municipal parking lot, the highway surface and high ground areas. These combined waters either enter the 6 inch drain under the front building or the 48 inch pipe under the back building. All these waters ultimately spill at the discharge of the 48 inch RCP and spill at the center of the high dump area. (Exhibit A).

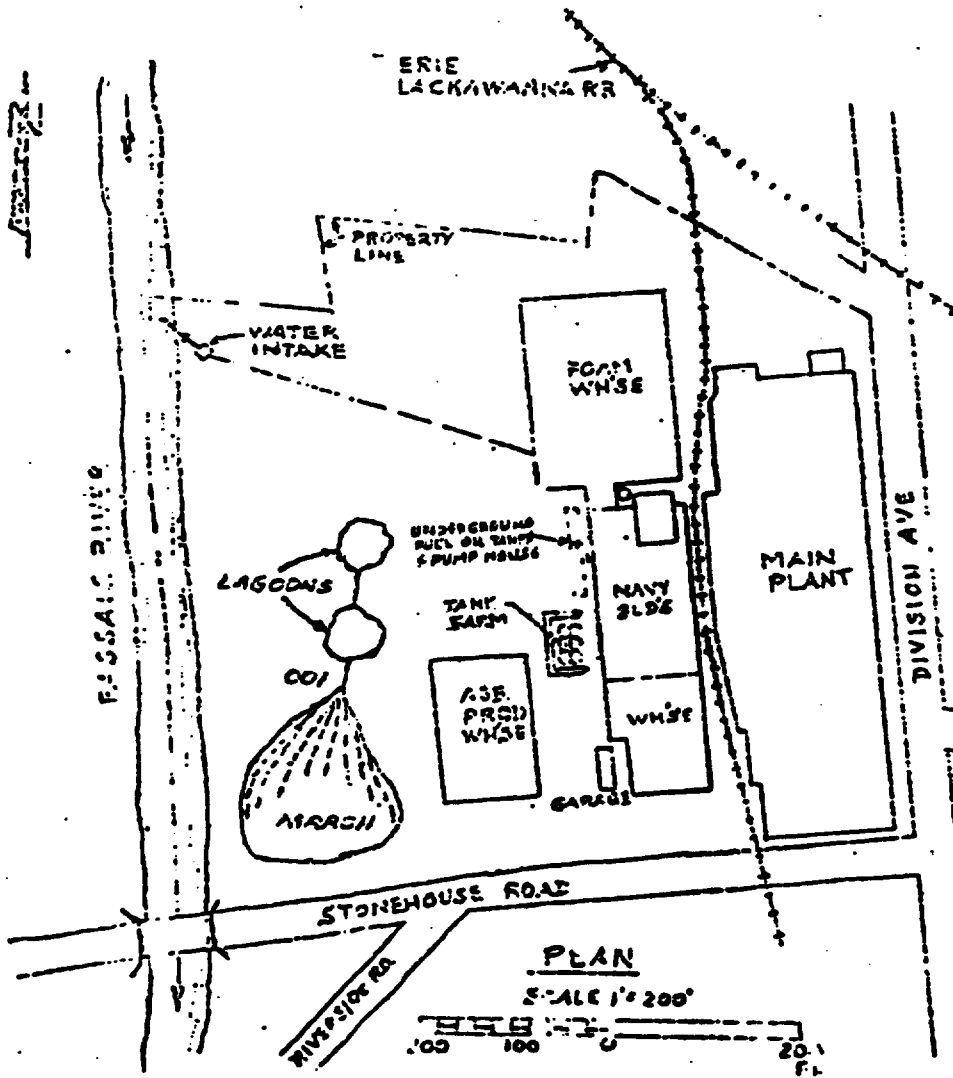
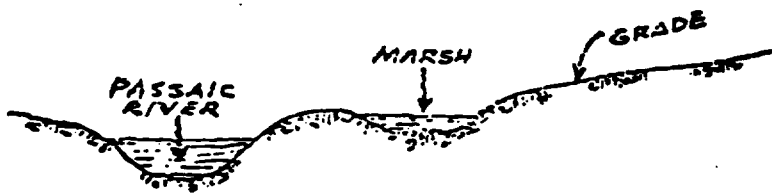
EXHIBIT "B"

This system was protected by a federal N.P.D.E.S. permit, was clearly established and functioned properly. (Exhibit B). It produced a clear clean water, void of solids and contaminants, and free of any B.O.D., toxicity or temperature problems. Periodic testing supports these statements with factual laboratory reports. The only element not within today's environmental standards was the pH or acidity measurement of this discharge. It was too alkaline, like the Passaic River water which was extracted for our process. It's a clear but very soft water, acting much like water that has been heavily dosed with Lime.

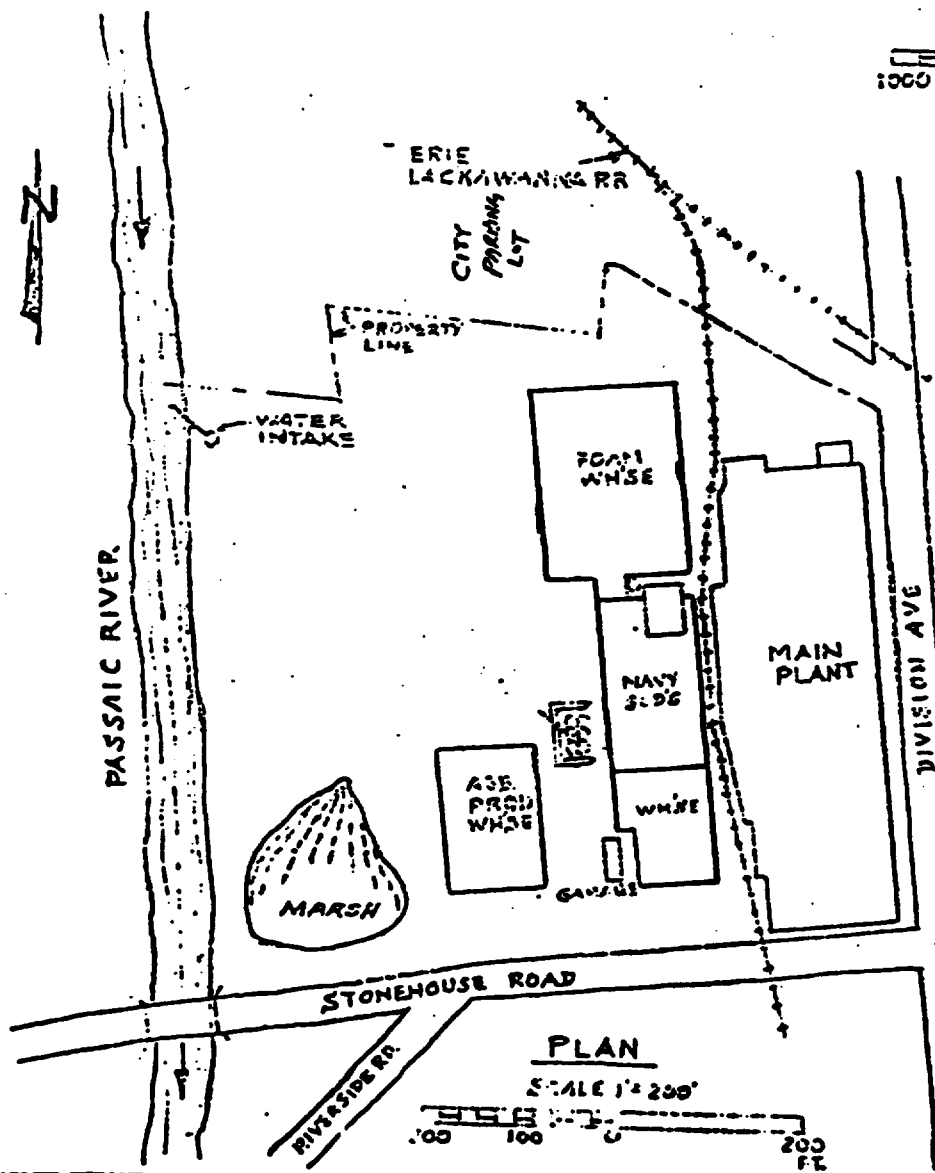
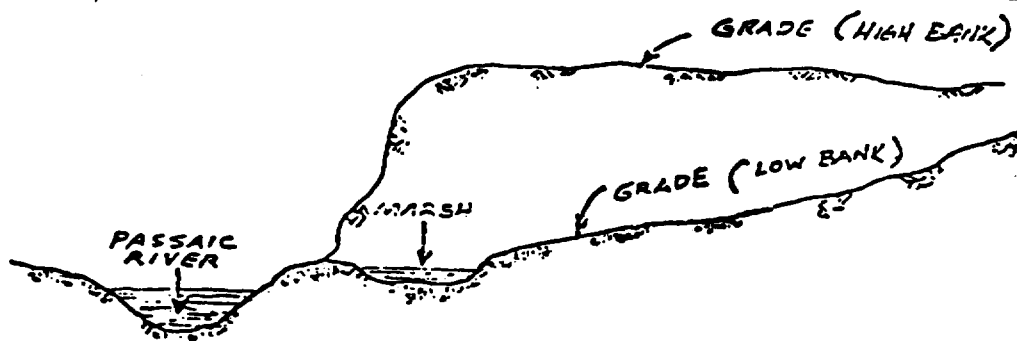
In vacating the site, the serpentine ditch network which conducted water to the two stage lagoon system was abandoned. The ditches and lagoons were filled and the site leveled, covered and seeded. (Exhibit C).

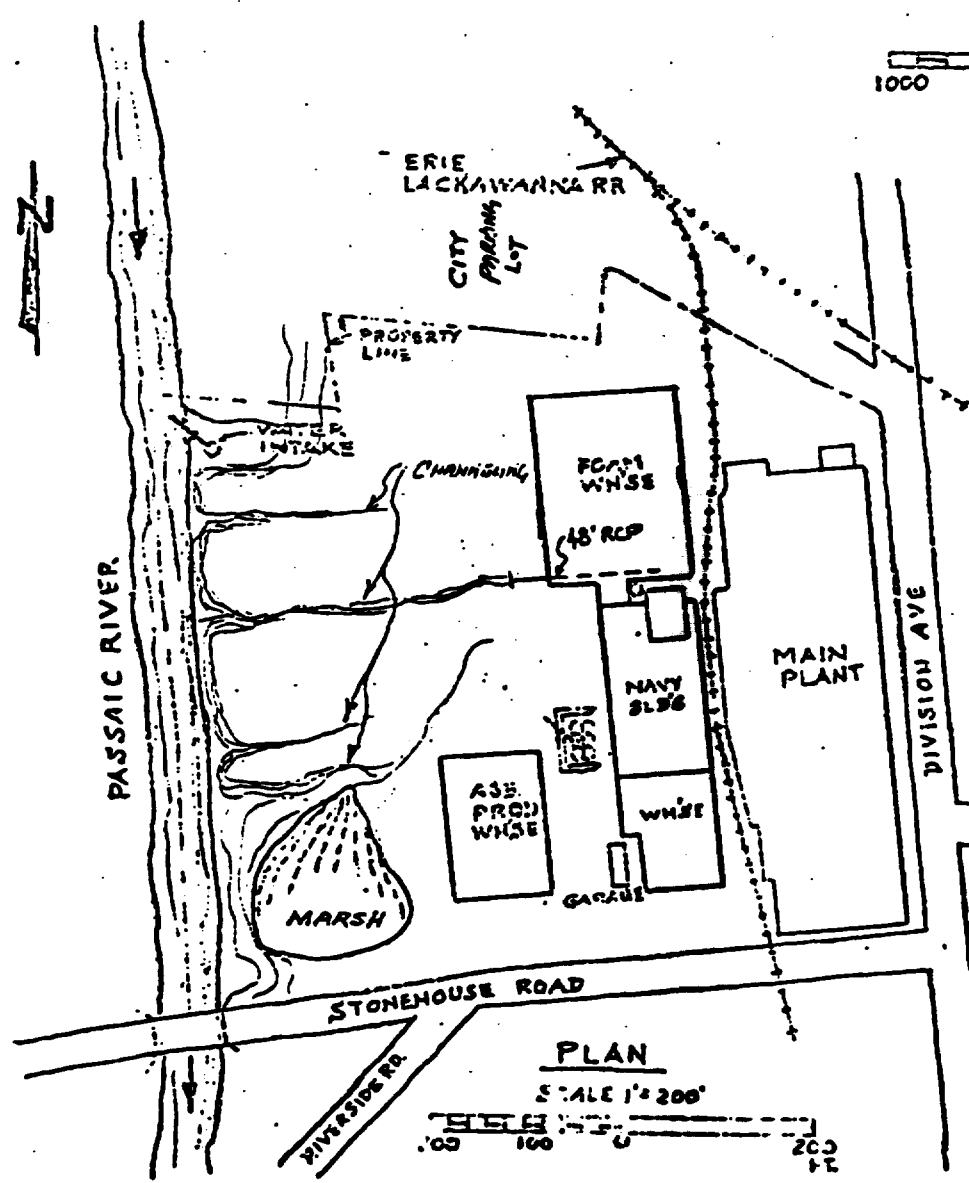
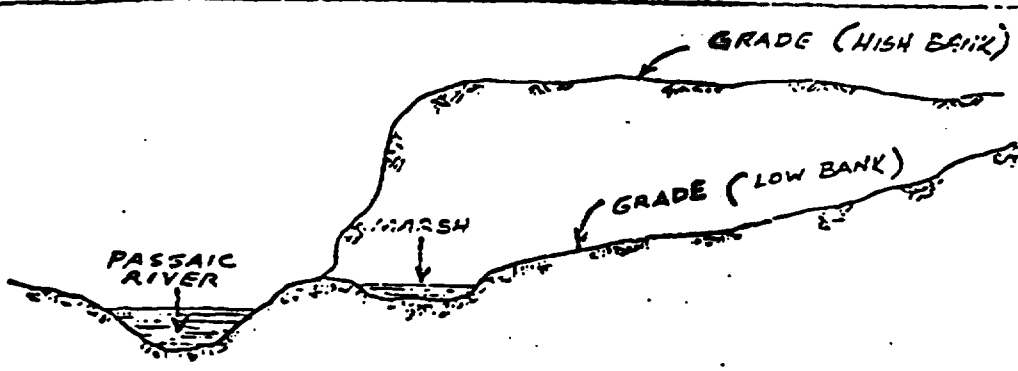
With this lagoon system filled, the water now digs its own course and spills over the high bank. As time passes, this channeling becomes more defined and the water caused erosion more severe. (Exhibit D).

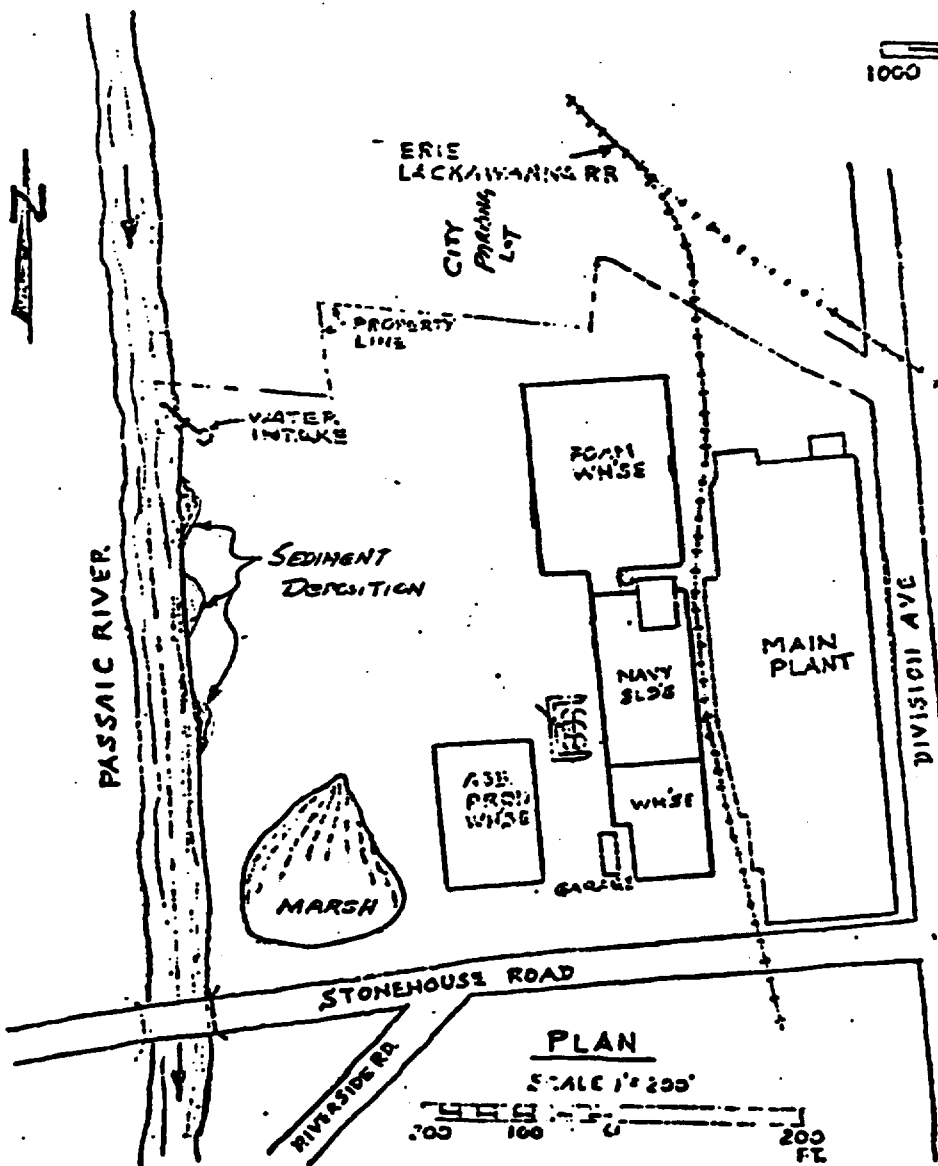
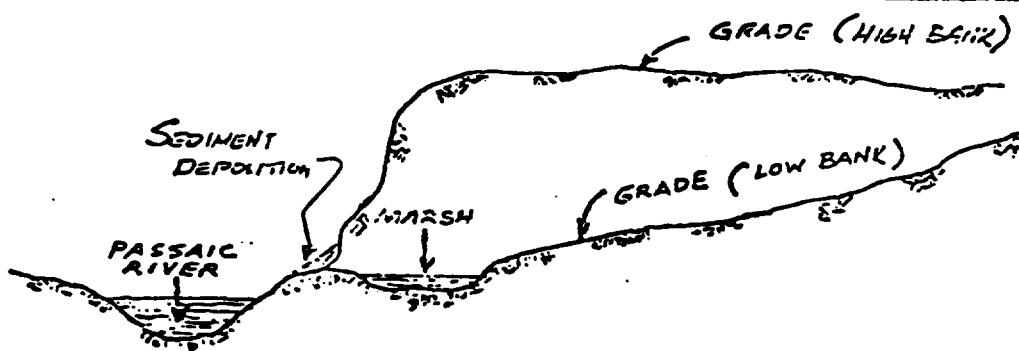
This erosion has deposited asbestos-cement residue on the low banks where, during high water flows in the Passaic River, it can become water bourne. (Exhibit E).
